Commission of Inquiry into the Collapse of a Portion of the de la Concorde Overpass

October 3, 2006 - October 15, 2007

REPORT

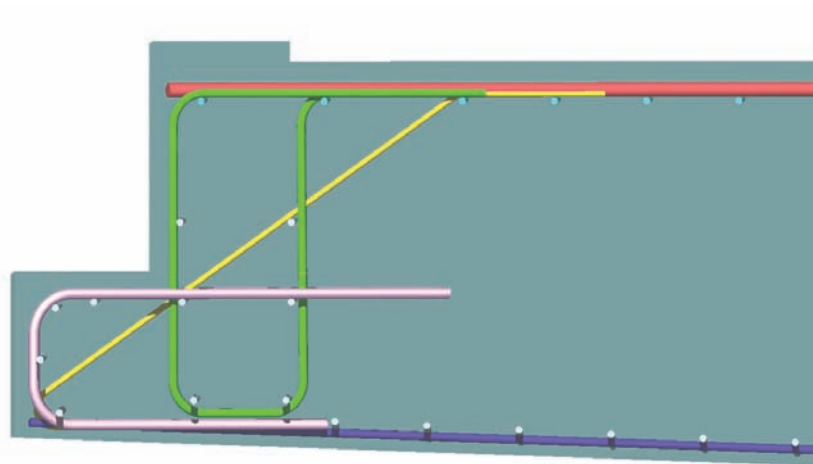
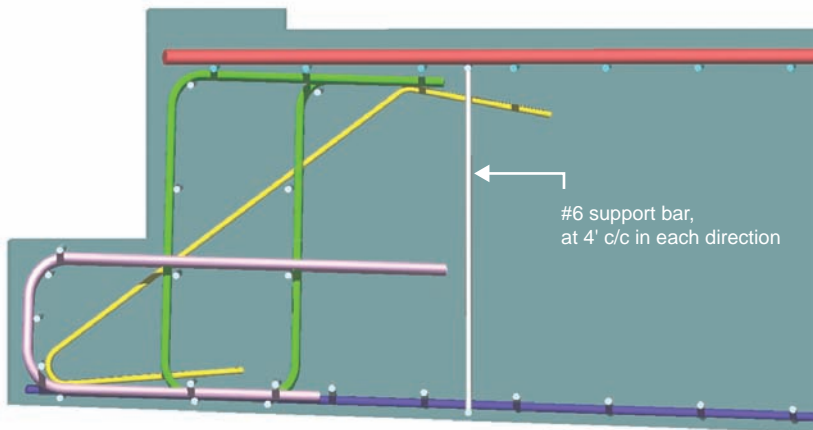
Figure 2.10 Layout of the Chair Bearing Support Reinforcements *As Designed* and *As Built* in the Cantiliver of the East Abutment

As the reader will note in Chapters 5 and 6, this installation of reinforcing bars contrary to the plans and specifications had important consequences. To assess its full significance, we must also appreciate the forces and stresses exerted on the concrete, which the reinforcing bars should normally allow it to withstand. This is the subject of the next section.

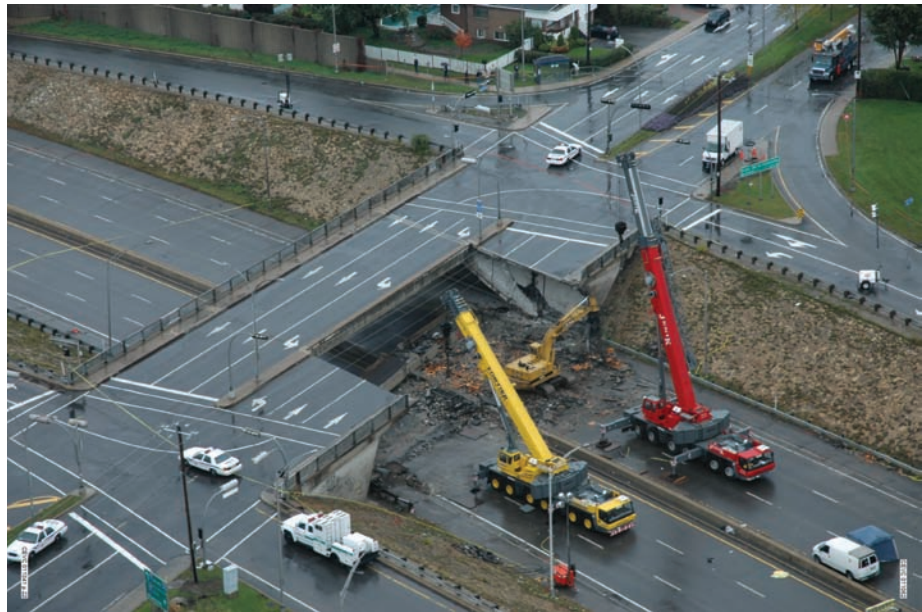
On Saturday, September 30, 2006, around 12:30 p.m., the south deck of the overpass located at the intersection of Boulevard de la Concorde and Autoroute 19 in Laval collapsed. The sudden fall of this overpass caused the deaths of five people and injured six others. The following pages describe the circumstances of the collapse, as presented in evidence by the main witnesses of this event or by the persons who participated in the first response, in securing the site and in the deployment of safety measures. A detailed chronology of the highlights appears in the summary of the police response.²

Figure 3.1 Collapsed Portion of the de la Concorde Overpass³

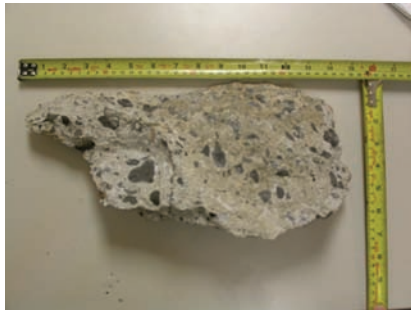
Figure 3.2 Concrete Block Picked up by Mr. Bonin

For Mr. Bonin, this concrete chunk constitutes [TRANSLATION] “ordinary debris”,¹⁶ similar to those he picks up near various structures, about once a month according to his recollection. Traffic was normal on the overpass. He did not notice any particular jumping, slowing of traffic, noise or vibration during the 15 minutes he spent on the scene, and no other concrete chunk fell. The top of the guardrail was at the same level on both sides of the expansion joint.

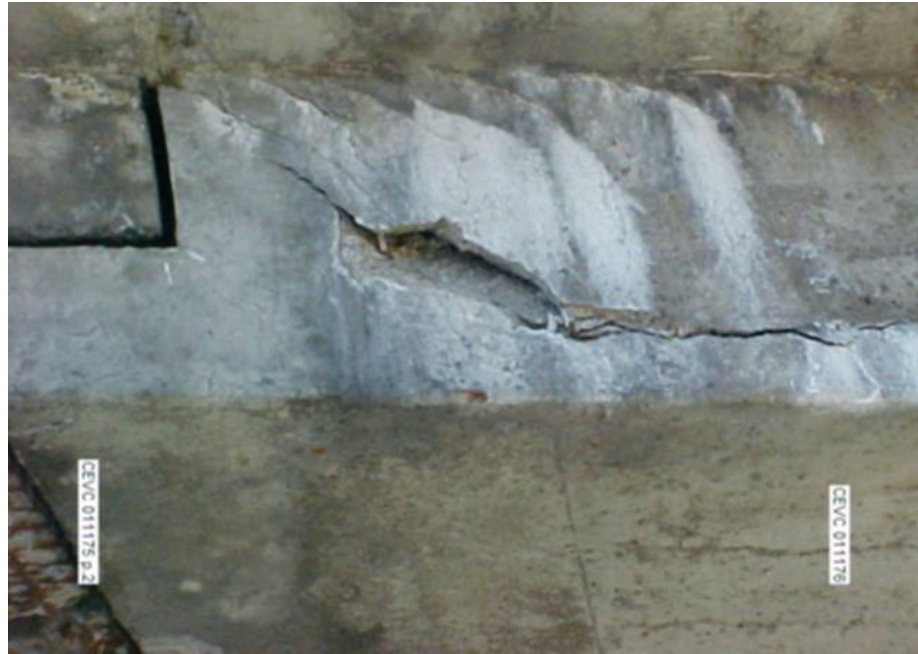
Figure 3.3 Hole and Crack in the East Abutment, photographed by Mr. Bonin between 11:45 a.m. and 12:00 p.m., September 30, 2006.

However, Mr. Bonin filled out an anomaly report in which he wrote [TRANSLATION] *“To be inspected PC”*¹⁸ (a written adaptation of a common French expression meaning a definite emergency). This is the first time that he had asked for an overpass to be inspected and in his testimony before the Commission, he specified that he wanted to be sure that the inspection [TRANSLATION] *“would be done the following Monday”*.¹⁹

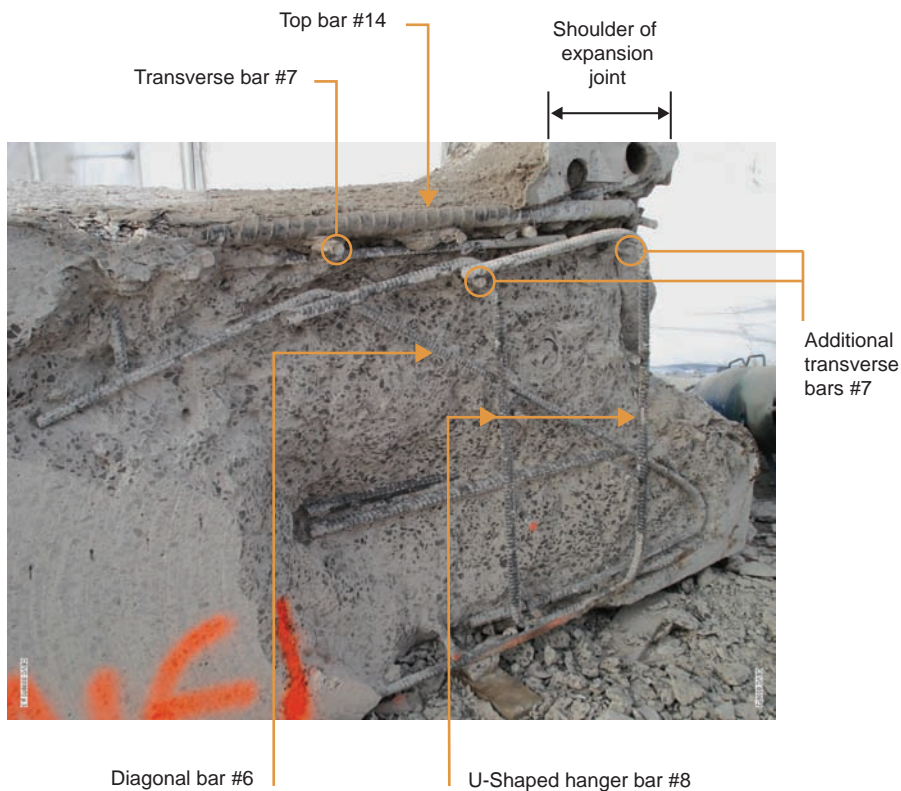
The U-shaped hanger bars were not installed as shown on the drawings (Figure 5.5). The upright parts of the hangers were not installed vertically. Furthermore, at the top of these bars, the hooks designed to transfer the load to the No. 14 bars were inclined, instead of being on the same plane and parallel to these bars, as intended by the designer. On the east side, the hooks are under the No. 14 bars, contributing to the creation of a zone of weakness.

Figure 5.5 Faulty placement of reinforcing bars in the bearing support area²⁸

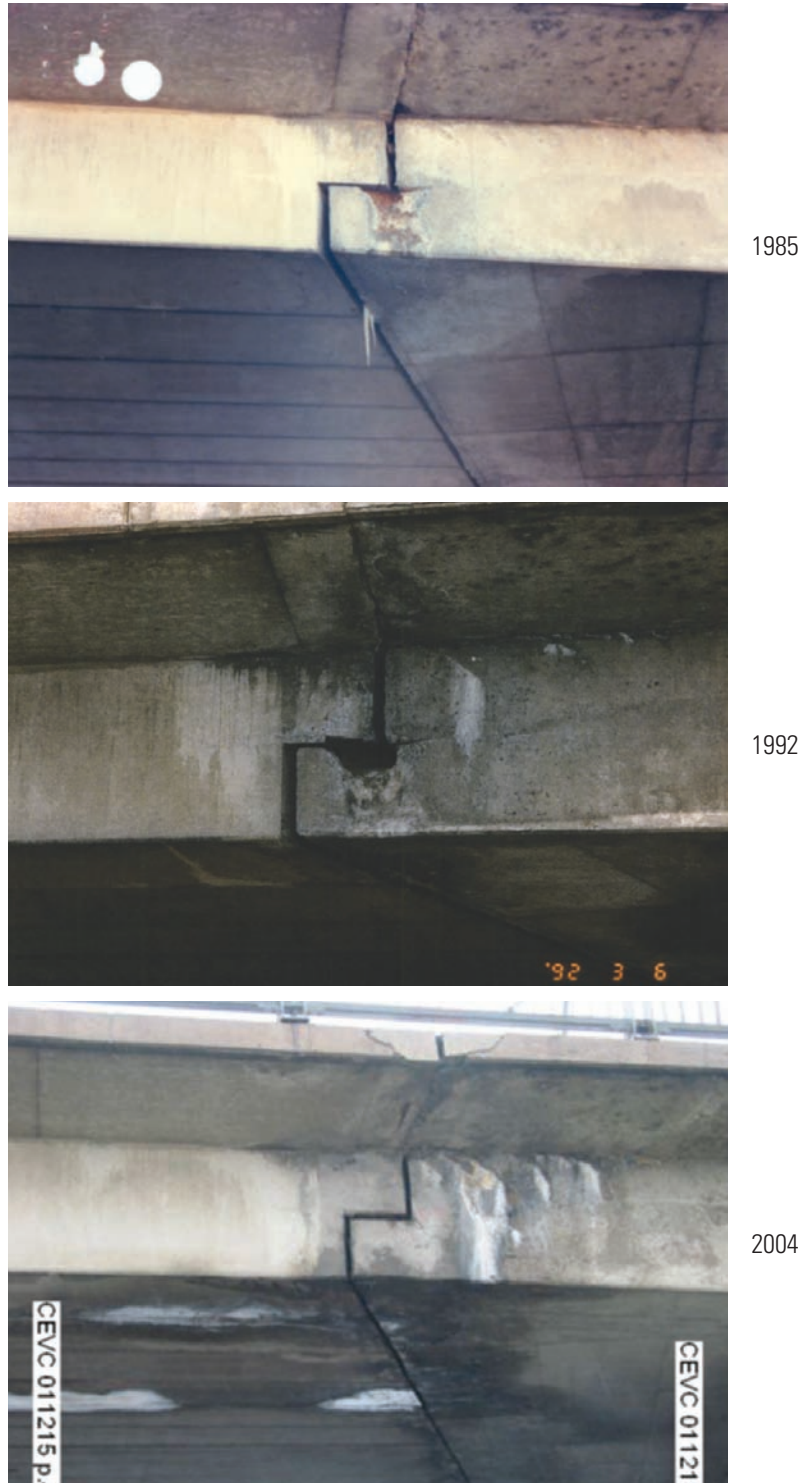
1992, it was impossible for him to appreciate the evolution of the problems, such as depicted in the photographic montage of Exhibit COM-68D (Figure 5.6).

Figure 5.6 Views of the east cantilever, from the south side of the de la Concorde overpass, showing the evolution of cracks in the bearing support area⁷⁸

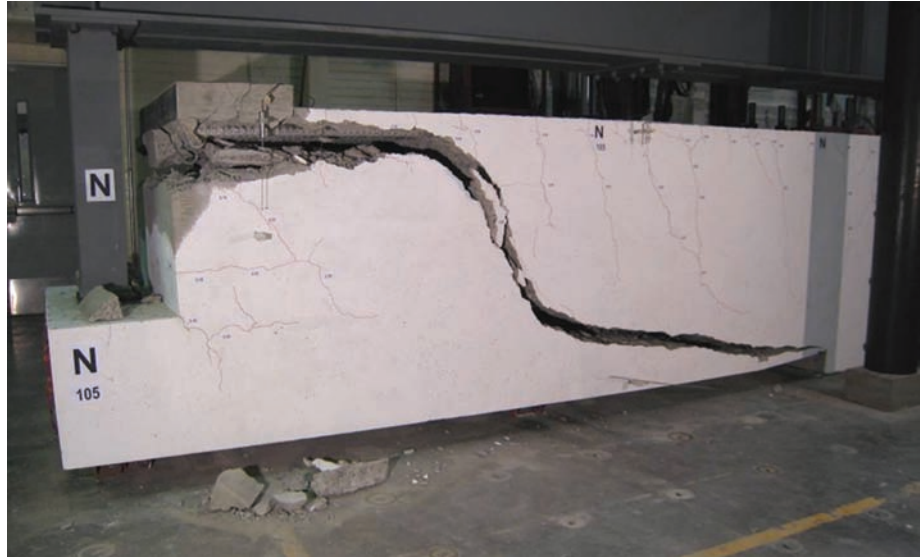
overpass (see Figure 5.7). In the upper part of the slab, a horizontal crack extends up to the end of the hooks of the hangers and diagonal bars. The crack then suddenly becomes inclined as a shear crack, traveling downwards through the slab, then finally turns horizontal along the lower rebars, splitting the cantilever up to the junction with the inclined wall.

Figure 5.7 Failure of the “as-built” cantilever during the laboratory loading tests at McGill University⁹⁰

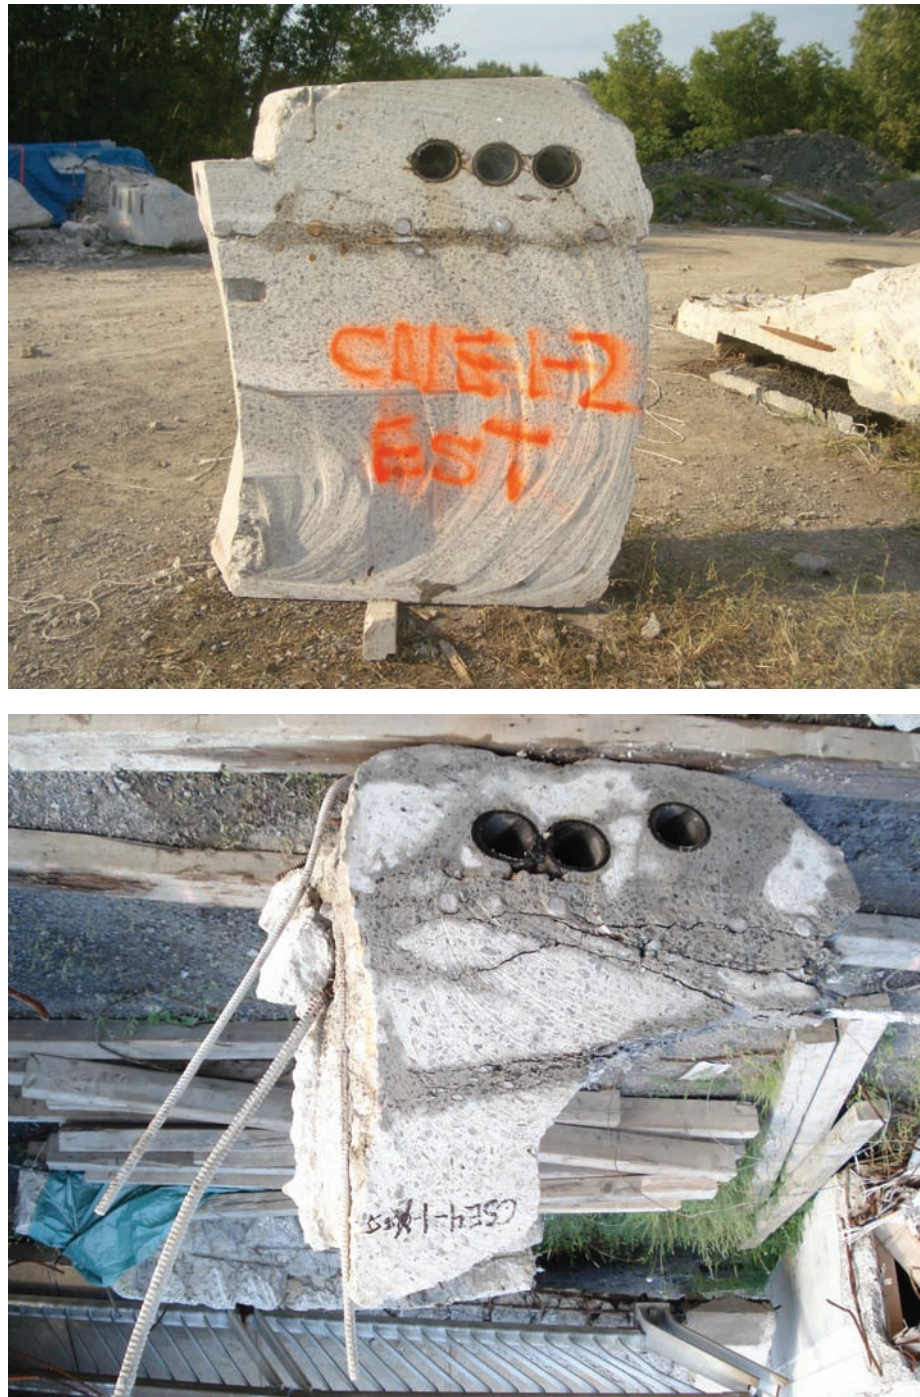
Observations made on the slices taken from block CNE1 from the northeast abutment, showed cracks of the same nature as those seen on the southeast side (Figure 5.8) and that this portion, although less loaded because of the skew in the structure, was liable to collapse at some point in time.

Figure 5.8 Transverse partial cuts of the east abutment performed during the additional dissection operations of August 2007 showing the northeast corner (top) and southeast corner (bottom)¹⁰⁵

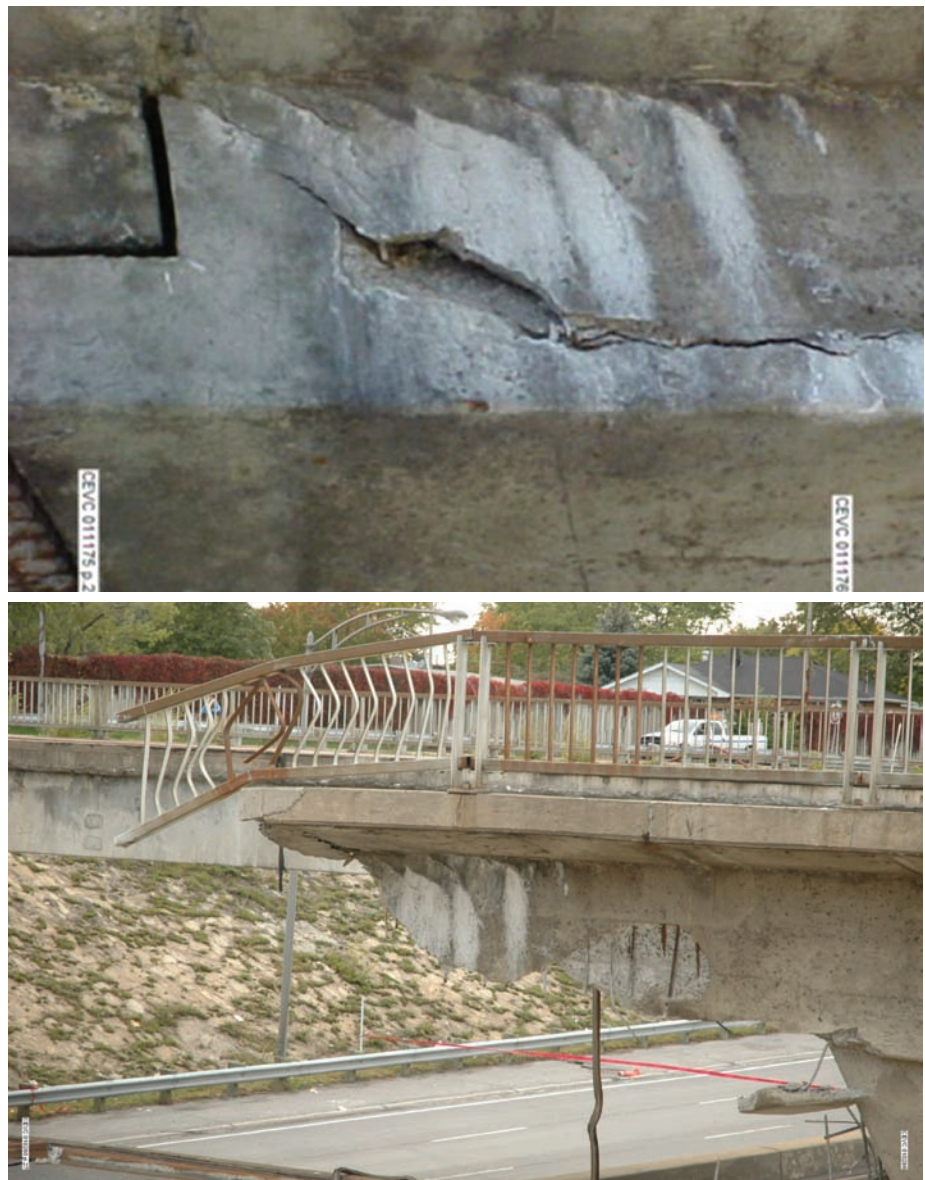
First, a piece of concrete approximately 700 mm long detached from an area just behind the corbel on the south lateral face of the east abutment (Figure 6.1 a).

Figure 6.1 Vertical face of the south side of the east abutment, near the corbel:
a) Top: picture taken by Jules Bonin on September 30, 2006,
less than 60 minutes before the collapse
b) Bottom: after the collapse

The unreinforced part of the internal concrete mass then abruptly split along an inclined surface down to the reinforcing steel at the bottom of the slab.

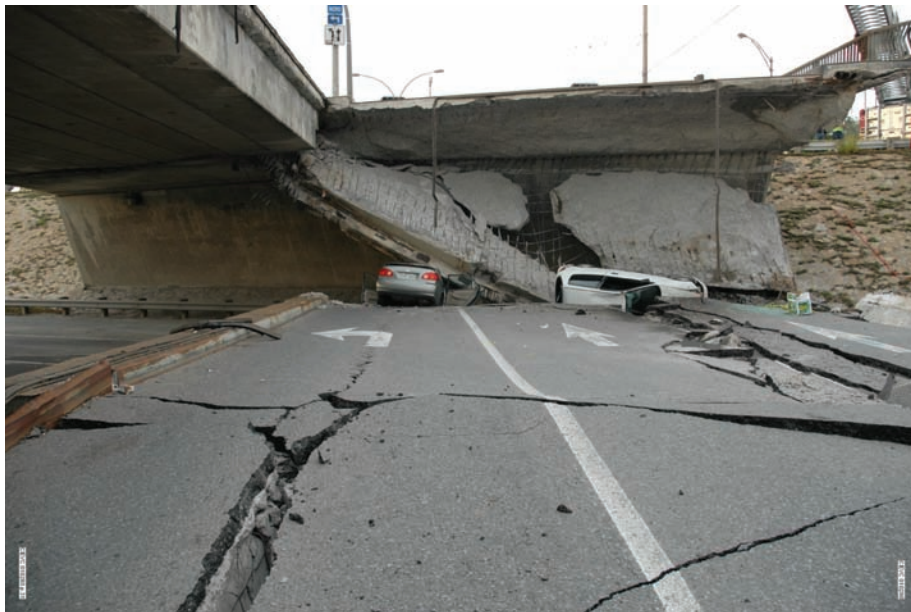
The overpass collapsed due to a shear failure in the south part of the east abutment's cantilever. The beam seat, or corbel, was not involved; this section remained attached to the lower portion of the thick slab following the collapse. The failure occurred in the core of the thick slab.

Figure 6.2 Front view of the east abutment shortly after the collapse, on September 30, 2006²

The upper part of the cantilever remained intact, hanging over Autoroute 19, whereas the lower part pivoted towards the ground, breaking into three large blocks and a number of smaller pieces (Figure 6.2). The three main pieces that separated from the bottom of the cantilever remained attached to the top of the abutment, held by the longitudinal rebars in the bottom of the slab and also partially by the transverse bars in the beam seat near the center of the abutment.

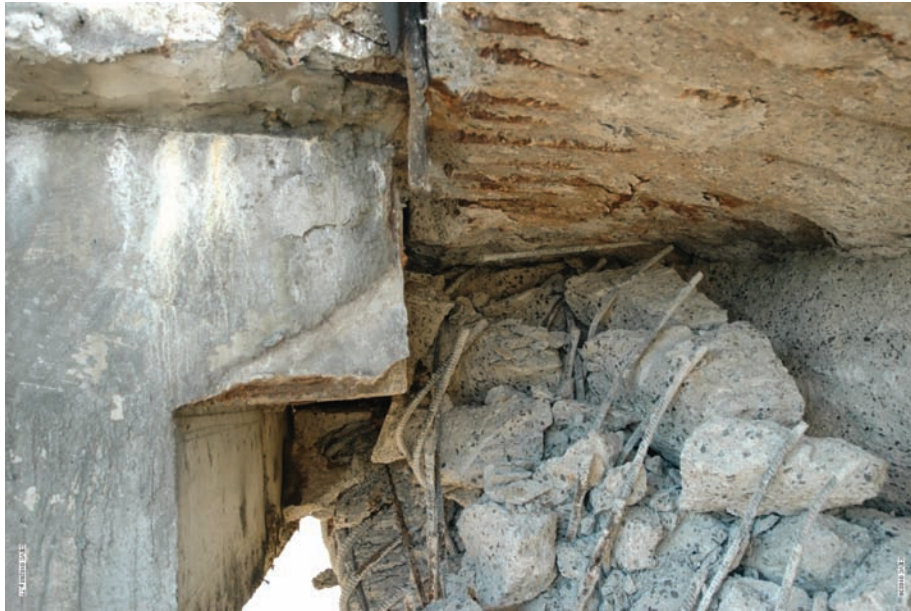
Towards the center of the cantilever slab, shear stresses gradually decrease as one moves away from the southeast corner, where the loads on the supports are more concentrated. The failure of the thick slab stops at the center of the abutment, at a point where the available resistance is sufficient to halt the splitting. The photograph in Figure 6.6 shows many U-shaped hangers severed at the root of the hooks, which indicates that these hangers did possess some anchoring capacity.

Figure 6.6 Photograph of the area of the corbel, towards the center of the abutment, where the slab stopped splitting.⁸
